Our Ref: J157547 FI: 5  
Your Ref: TBC  
Date: 07/12/2018

**MANAGEMENT ASBESTOS SURVEY**  
**OF**  
**ST MARY'S PARISH CENTRE,**  
**GREEN ROAD,**  
**GOSPORT,**  
**HAMPSHIRE**  
**PO12 2ET**  
**ON BEHALF OF**  
**ST MARY'S PARISH CENTRE**

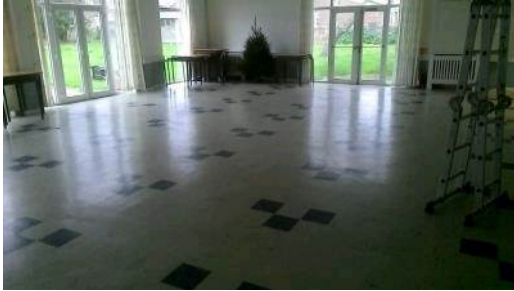
*Cream vinyl floor tiles and adhesive - Sample 1 - Asbestos Identified -  
Recommendation - Manage*

**Sample 1:** St Marys Parish centre,  
Gosport. Ground Floor. Main Hall.  
Cream vinyl floor tiles and adhesive

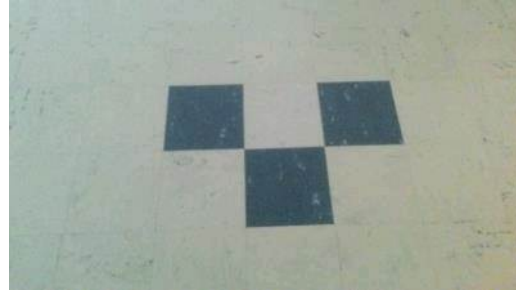
*Blue vinyl floor tiles and adhesive - Sample 2 - Asbestos Identified -  
Recommendation - Manage*

**Sample 2:** St Marys Parish centre,  
Gosport. Ground Floor. Main Hall. Blue  
vinyl floor tiles and adhesive

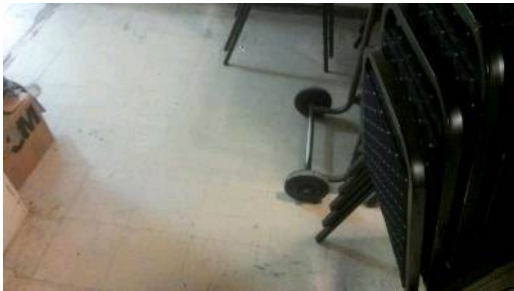
*Vinyl floor tiles and adhesive - Sample 4 - Asbestos Identified -  
Recommendation - Manage*

**Sample 4:** St Marys Parish centre,  
Gosport. Ground Floor. Main Hall Store  
Cupboard. Vinyl floor tiles and adhesive

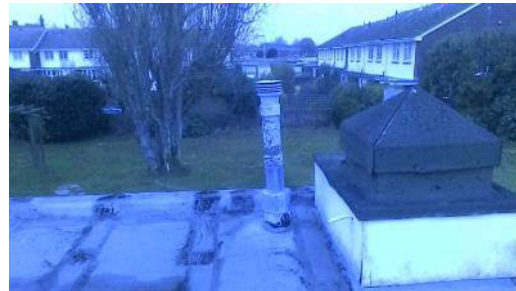
Cement flue to flat roof area Visual 1  
*Recommendation - Manage*

Visual 1	External External, Cement flue to flat roof area	Presumed	1 lm	Usually inaccessible or unlikely to be disturbed	Asbestos Cement	1	Good Condition	0	Surface Sealed	1	Crocidolite (or unknown)	3	Low	5	Management of ACMs (Manage)

**Visual 1:** St Marys Parish centre,  
Gosport. External. External. Cement flue  
to flat roof area
